**OKLAHOMA CITY FIRE DEPARTMENT  
FIRE PREVENTION SERVICES  
FIRE INVESTIGATION UNIT**

**ORIGIN AND CAUSE REPORT WRITTEN BY FIRE INVESTIGATOR J. HOFFMAN:**

**OKC Fire Suppression Incident Number (ERS#): 2022-10149**

**Incident Address: 6161 N Western Ave.  
Oklahoma City, OK 73118**

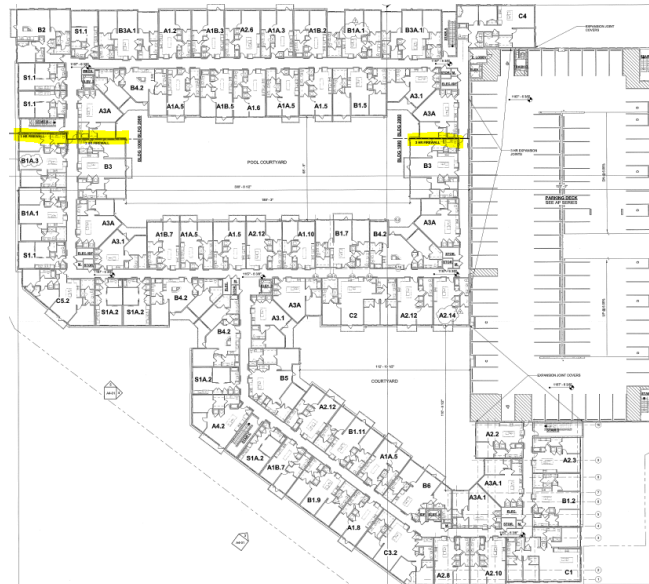
structure had 374,507 square feet in all of the buildings, and the parking garage was 176,896 additional square feet. The building plans indicated a fire wall on the west and east portions of the structure.

Highlighted Areas with 3-Hour Fire Walls

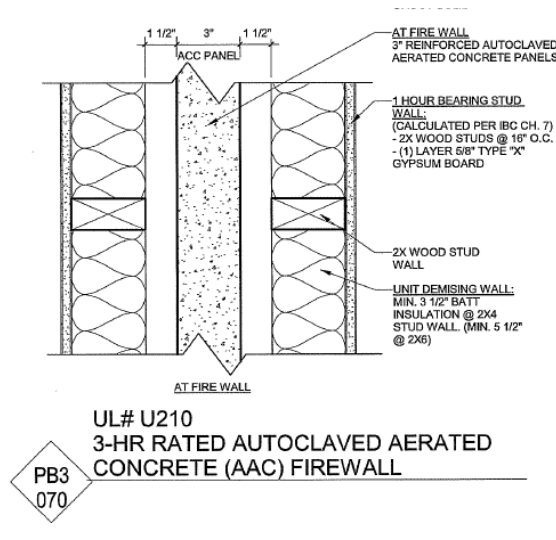
3 Hour Firewall Construction Details from the building plans

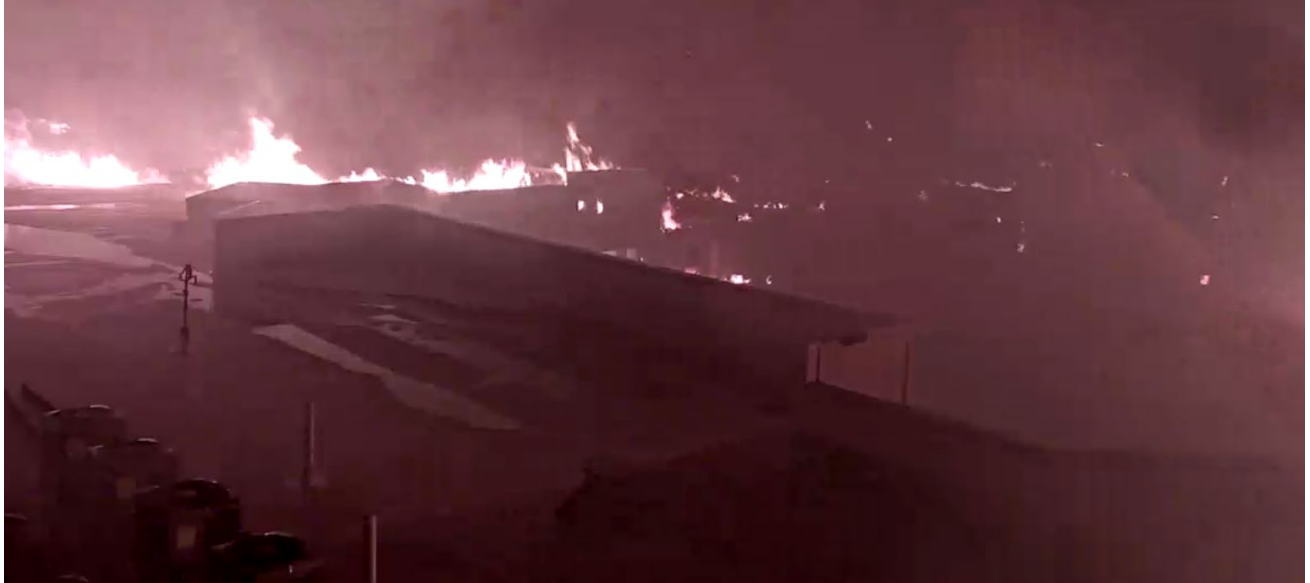
The fire on the roof quickly spread to the east (as the wind was blowing in that direction).

Pictures from video provided by CMS Willowbrook. The camera is located on the north side of the parking garage and is facing southwest.

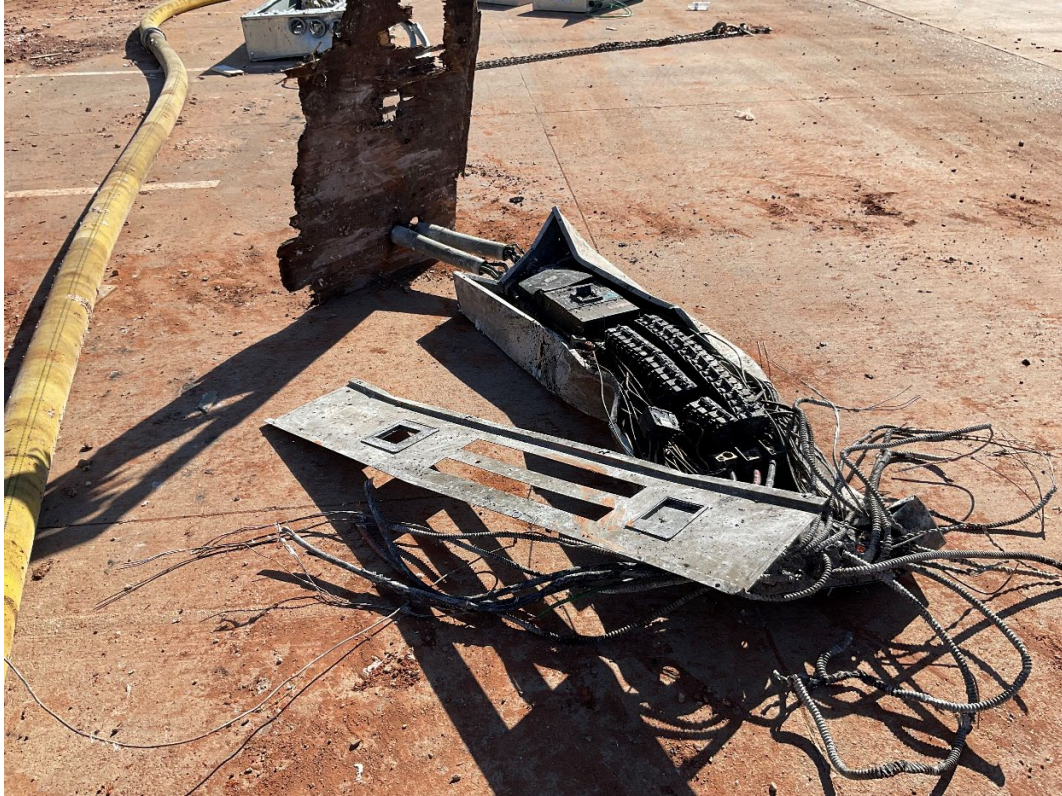
extensive charring, but the rooms above & below the interstitial space had not caught on fire. I also retrieved a electric sub-panel with the conductors & conduit which had run down beneath the floor. The flooring the conduit and conductors had run into was also retrieved. The flooring was not burned on the top but was heavily charred on the bottom. The sub panel was damaged from the demolition but had no signs of flame impingement or soot deposits. The conduit had also melted away along with the insulation sleeve from the conductors inside the interstitial space. I also observed burning in the interstitial space between the fourth and fifth floor. (See the following four pictures).

4<sup>th</sup> floor sub-panel and a piece of flooring

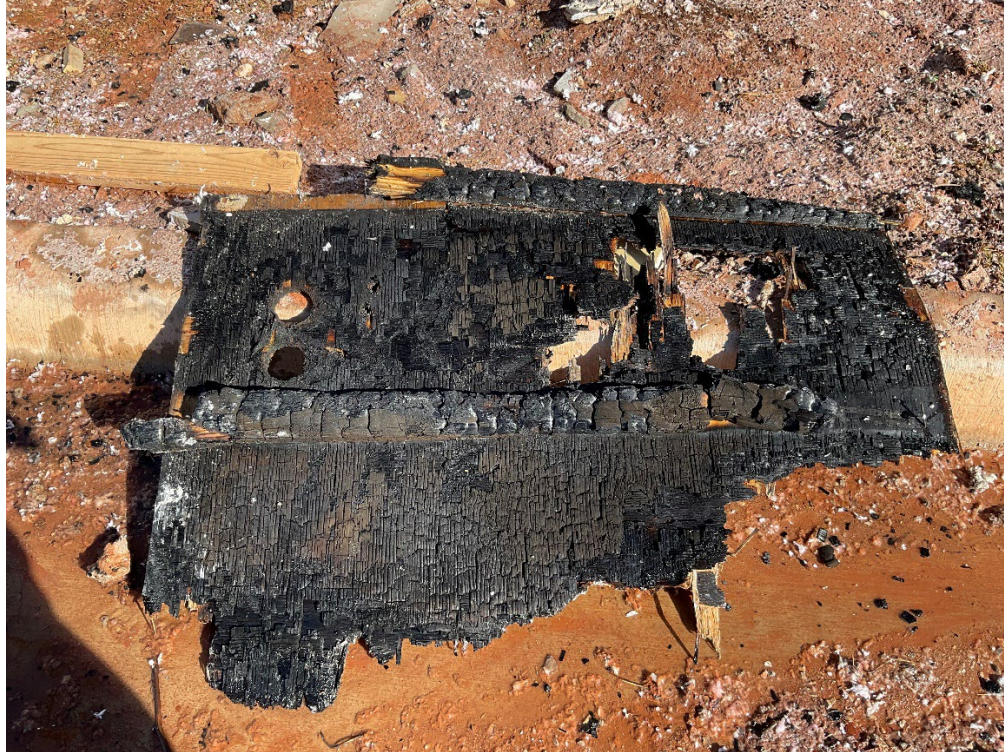
Bottom of flooring from 4<sup>th</sup> floor electrical room; southwest area of building
